**Subject: Annual Inspection Report**  
**Aliceville Municipal (George Downer Field) Airport**

AUGUST 12, 2009

ALICEVILLE MUNICIPAL (GEORGE DOWNER FIELD)  
AIRPORT

# **Annual Inspection Report Aliceville Municipal (George Downer Field) Airport Aliceville, Alabama**

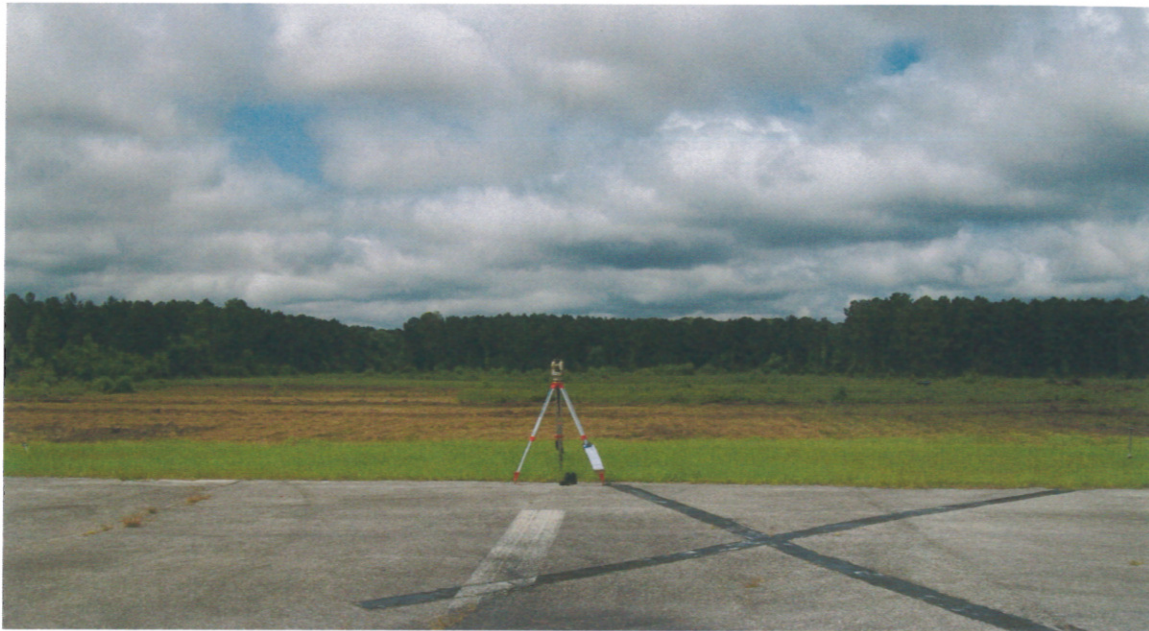
**Photo # 1 – Runway 24 Approach/Departure Path**

- Runway 24: No obstructions (See Photo # 1).
- Runway16: No obstructions (See Photo # 2).

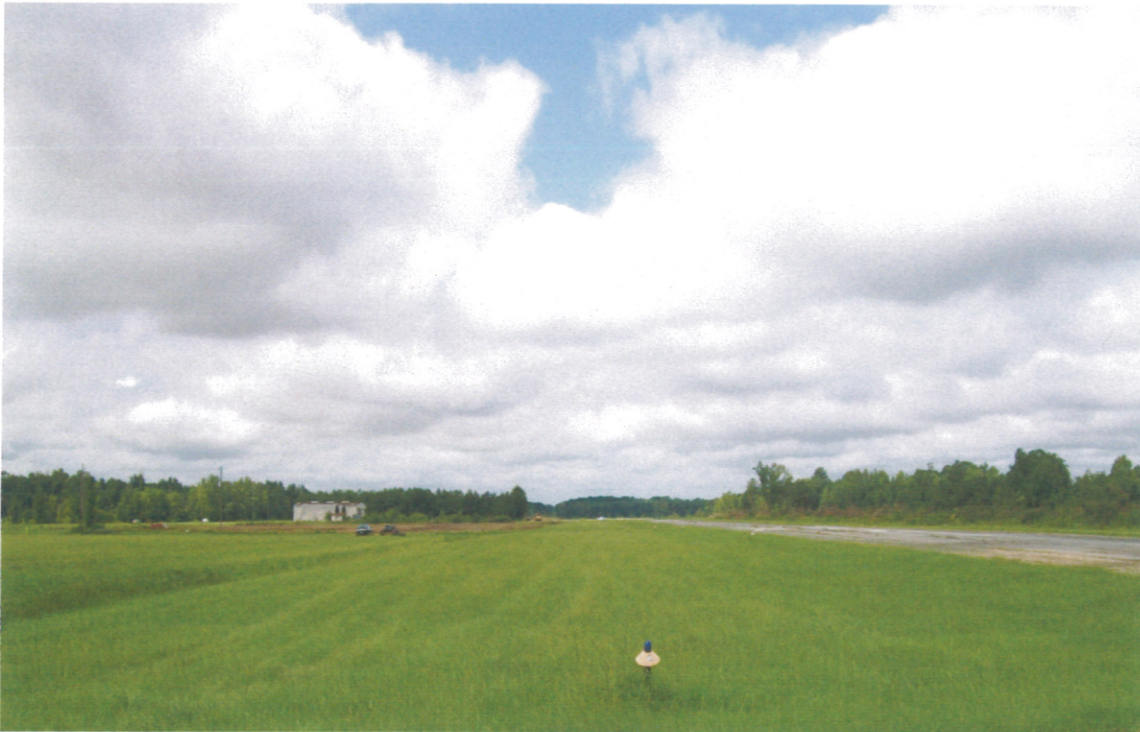
**Photo # 3 – Primary Surface**

- The primary surface meets state safety requirements (See Photo # 3).

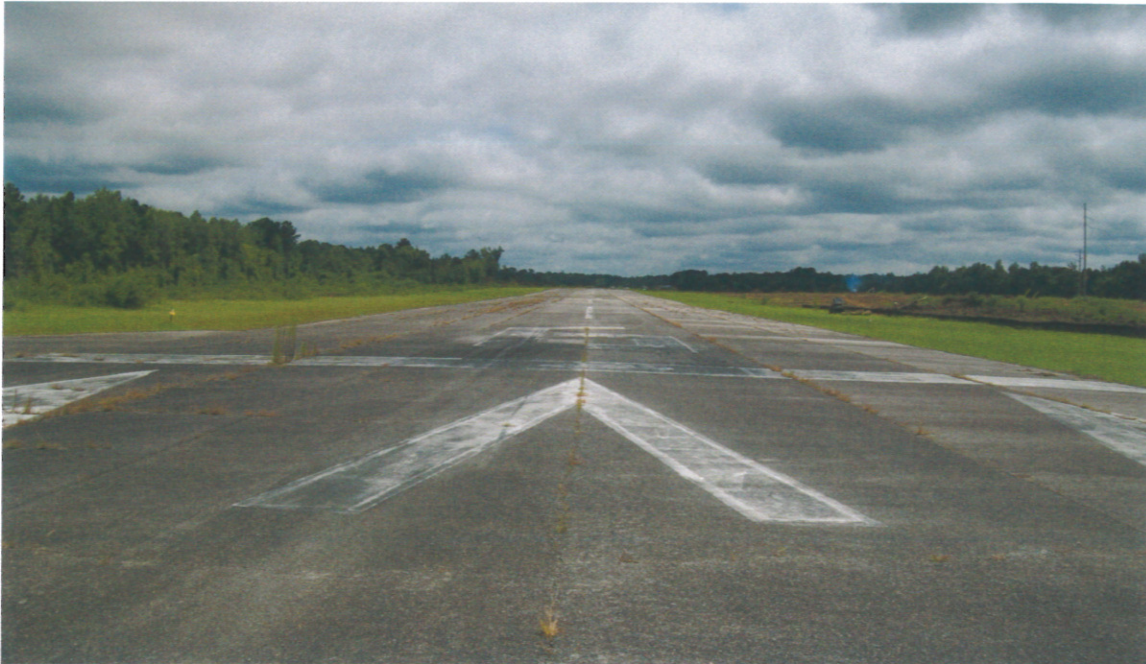
**Photo # 4 - RWY 16 Markings**

- The airport markings are faded (See Photo # 4).

- The runway markings should be remarked in accordance with FAA AC150/5340-1J "Standards for Airport Markings".

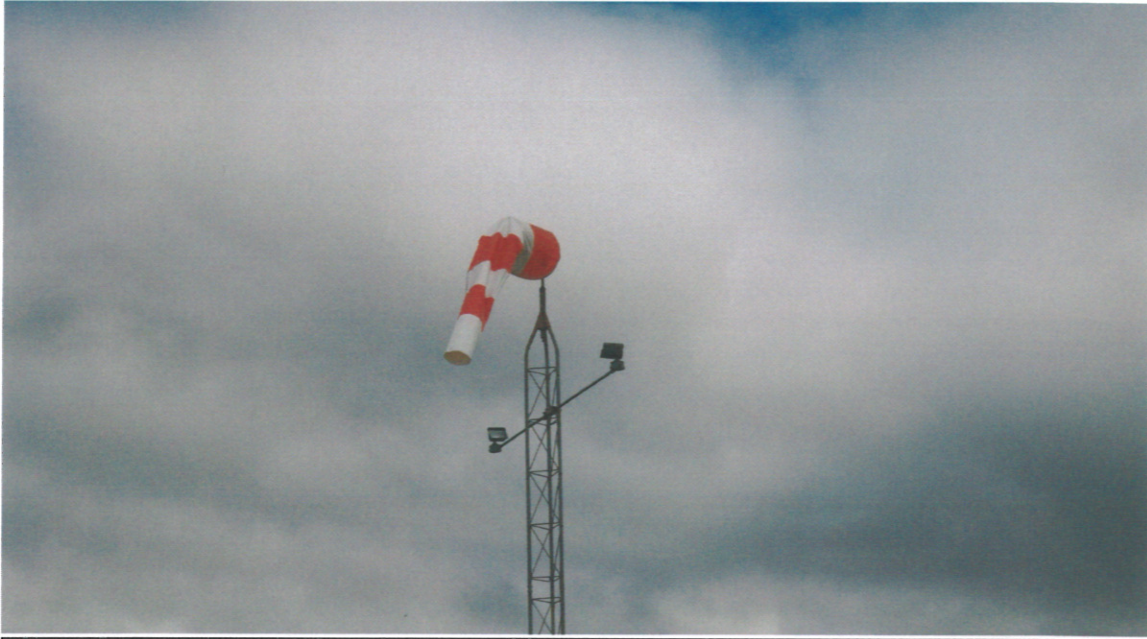
Photo # 5 – Wind Cone

- The wind cone meets state licensing standards (See Photo # 5).

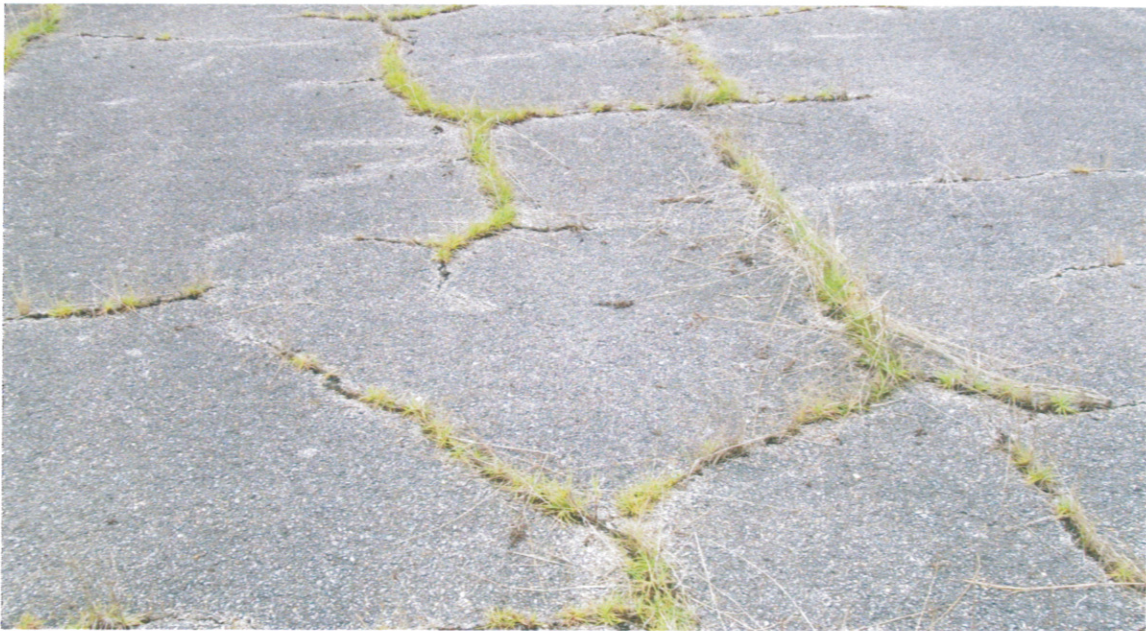
**Photo # 7 – Runway Surface**

- The overall condition of the airport pavement surfaces was found to be in fair condition. The surface contained thermal and joint cracks with vegetation growing from most cracks. There was evidence of moderate to extensive raveling (See Photo # 7).

- The airport's fiscal year 2009 pavement rehabilitation project will repair the noted pavement surface condition.
